Seismic Risk Assessment

REPORT NO. SRA-61-05

BLOCK #44-2 (GYMNASIUM)

UPLANDS ELEMENTARY SCHOOL

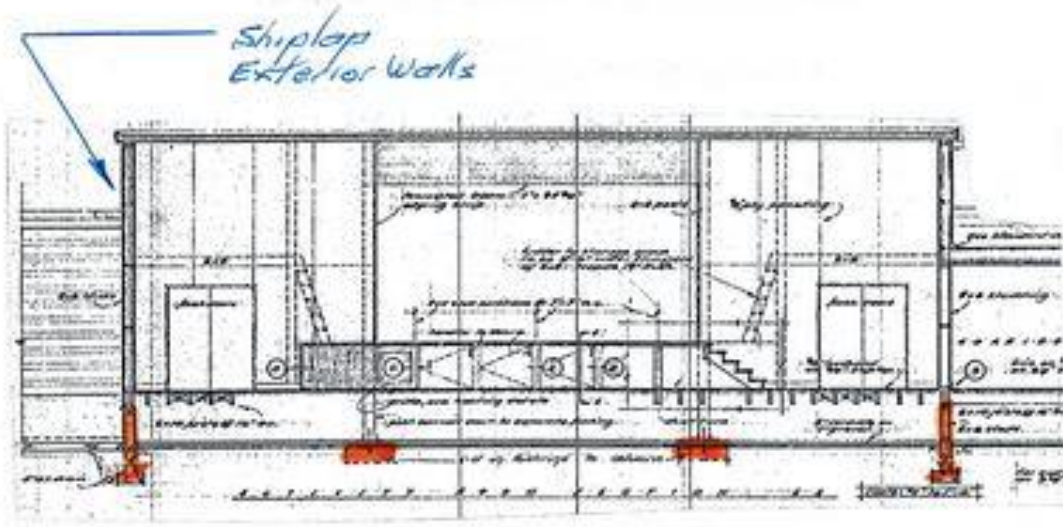
Figure 3.1: Typical Section
Block #44-2
Gymnasium
Uplands Elementary School

A typical cross-section of the block is given in Figure 3.1. A description of the significant structural elements in this block is as follows:

The in-plane behavior of the exterior wood frame walls is the governing element of this block. Figure 3.1 illustrates a typical gymnasium configuration. The north and south exterior walls are the governing gymnasium walls (east / west shaking).

Exterior Walls: This risk ranking is governed by the in-plane performance of the exterior wood frame walls.
